ANNUAL DIGEST

CHIRP

2023

Annual Digest of Reports and Insight Articles 2023-24

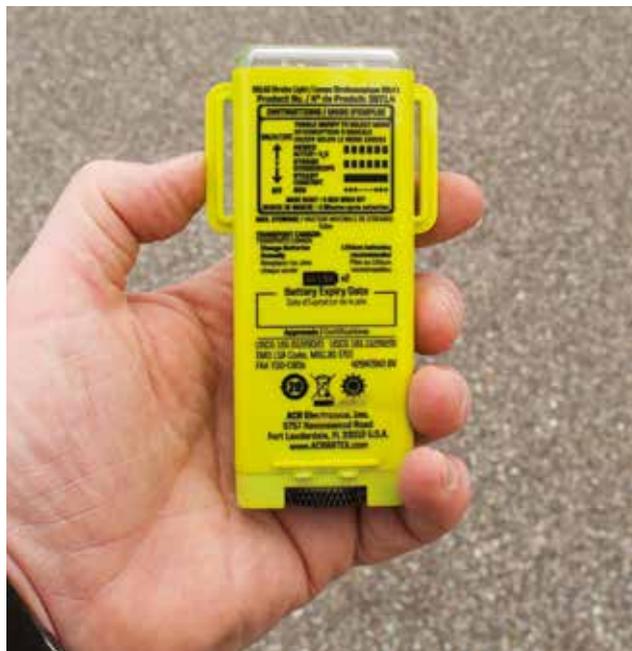
A typical personal locator beacon (PLB)

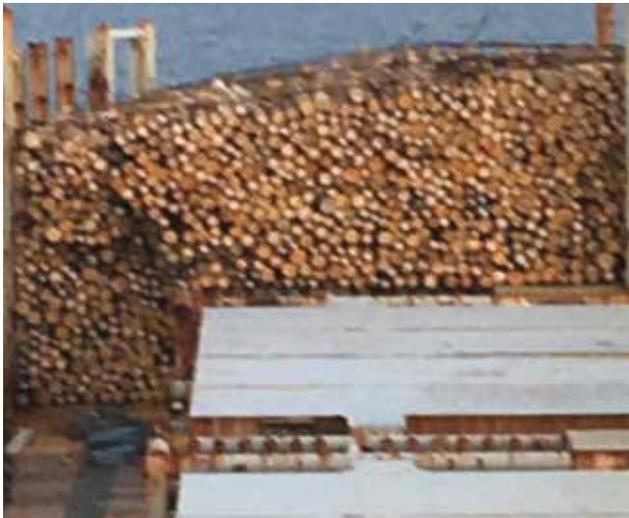
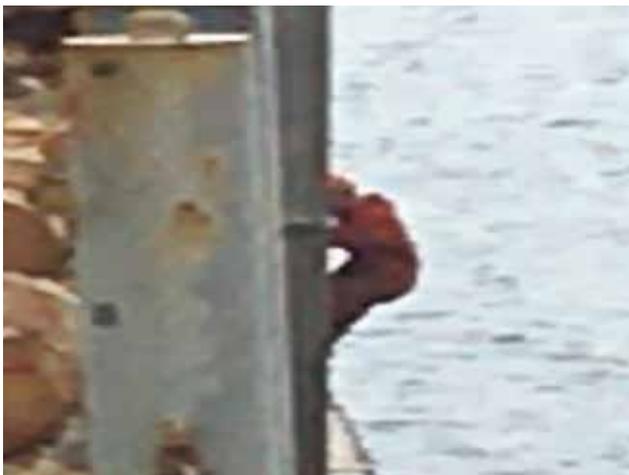
Unsafe access for the crew on a logger

This is a lethal accident waiting to happen.

Vessel owners remain responsible for maintenance in most cases, and they should ensure that such hidden hazards are removed as soon as possible, or at the latest, during the vessel's next maintenance period.

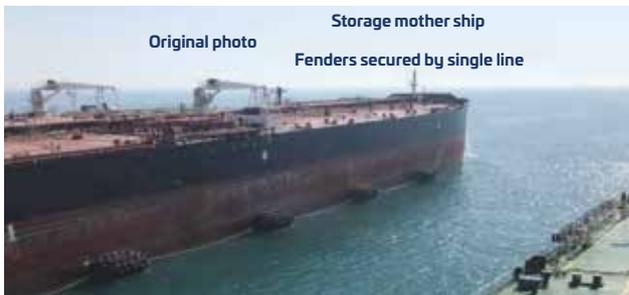
Our reporter sent a photo of a storage ship with incorrectly rigged fenders, noting that a failure of any of the fender's securing lines will lead to a failure of the complete fender protection system.
