ATSB TRANSPORT SAFETY REPORT  
Marine Occurrence Investigation No. 274  
MO-2010-003  
Final

Independent investigation into the grounding of the  
Chinese registered bulk carrier

# Shen Neng 1

on Douglas Shoal, Queensland

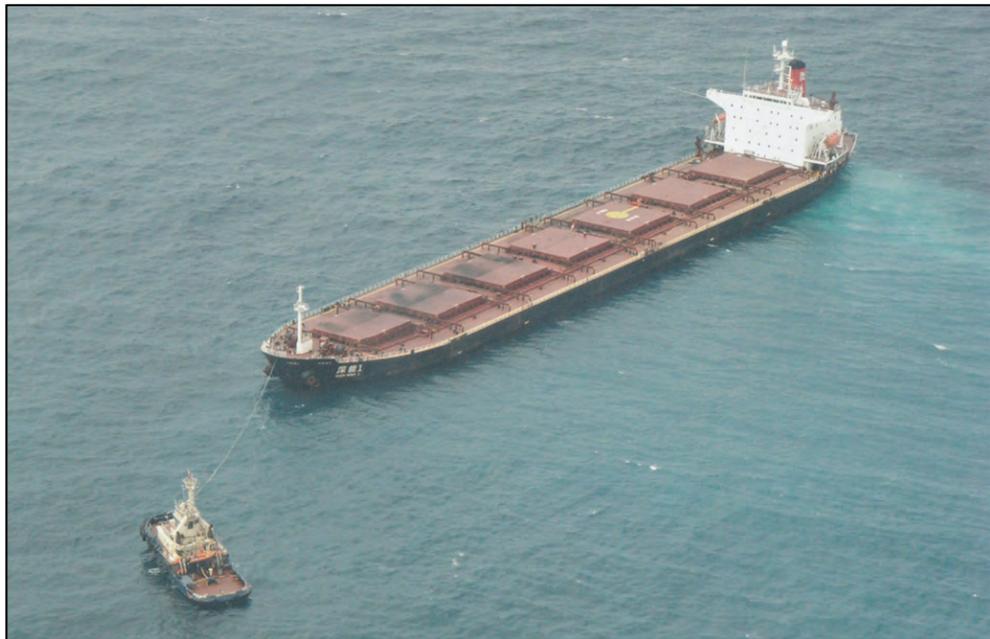
**Figure 1: *Shen Neng 1* aground on Douglas Shoal**

included trying to remove as much fuel oil from the ship as possible. The ship's hull was seriously damaged by the grounding, with the engine room and six water ballast and fuel oil tanks being breached, resulting in about 2½ tonnes of fuel oil being lost into the sea.

Between 29 April and 1 May, a more thorough underwater inspection of the damage was carried out while the ship was at anchor off Gladstone. The inspection revealed that the ship's bottom had suffered extensive plate damage. This damage comprised plate indentation, push-up, buckling and cracking. The rudder was slightly damaged but the propeller was not.

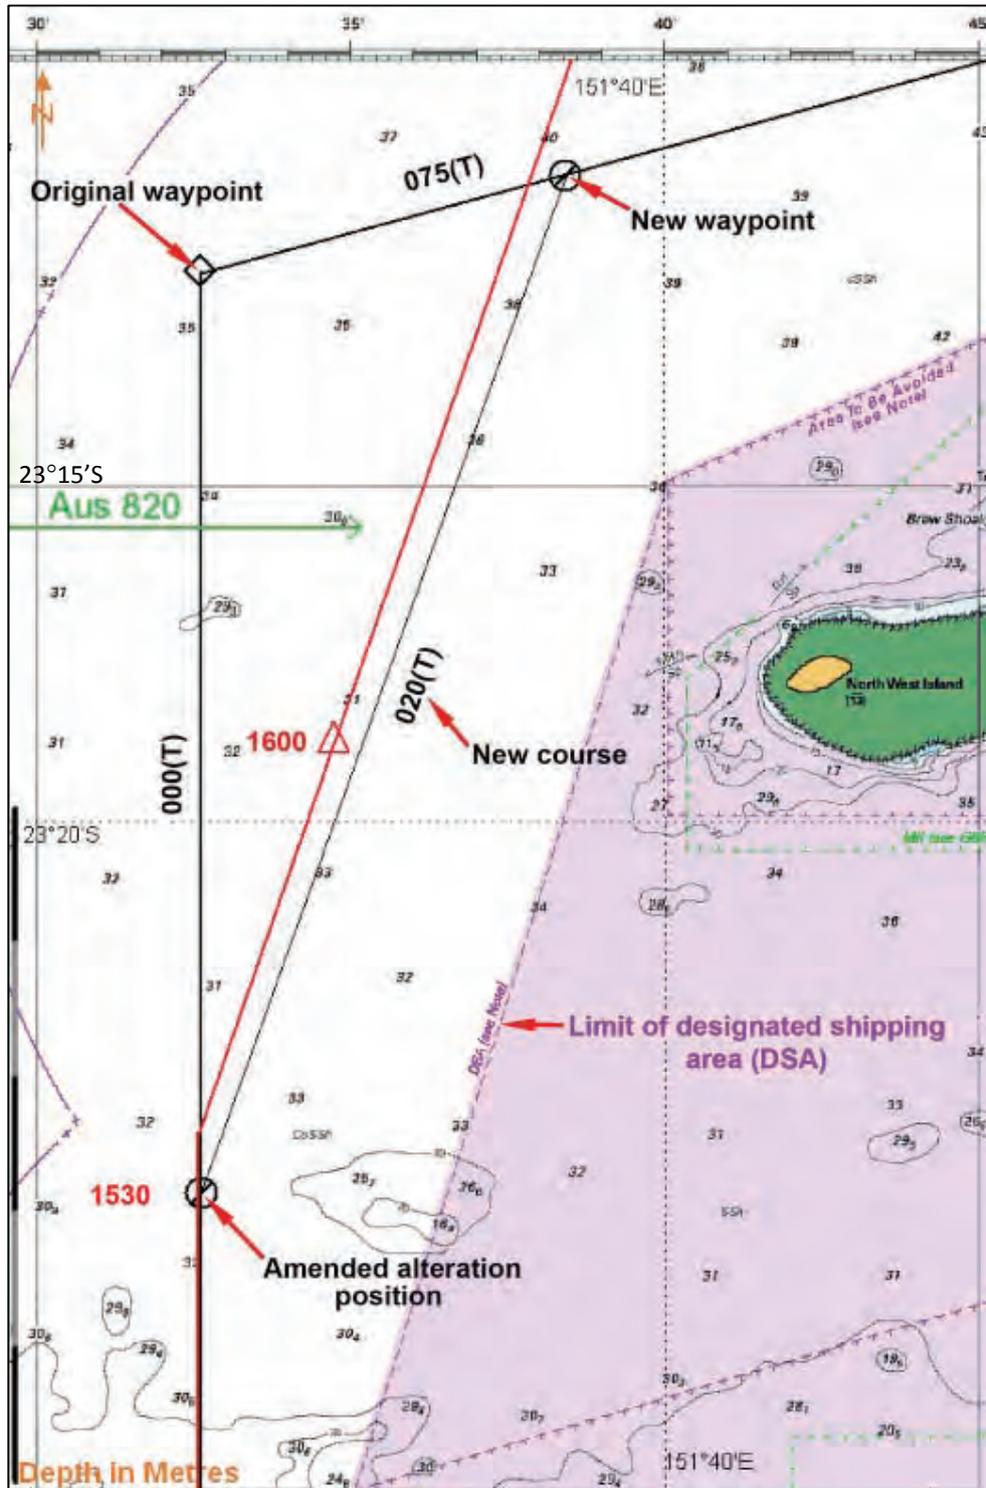
Figure 5: Annotated section of navigational chart Aus 819 showing the original and amended route, and the ship's position fixes (the red line indicates the ship's actual track)

Shortly afterwards, the auto-pilot was engaged and the duty seaman posted as a lookout. The second mate asked the master if he could adjust the planned route to slightly reduce the distance of the voyage and indicated the proposed new track on the chart. This new course would amend the planned passage just off North West Island and bypass the next course alteration waypoint (from 000° (T) to 075° (T)). The new course would rejoin the 075° (T) track further to the east than planned, thereby reducing the distance by nearly 2 miles (Figure 5).

The second mate laid the new course line of 020° (T) on the chart in use and on the next one, charts Aus 819 and Aus 820 respectively. The original course line of 000° (T) marked on both charts was not erased. A 'change of chart' line with the notation 'Aus 820' which had been marked on chart Aus 819 across the 000° (T) course line also remained unaltered.

When amending the passage plan, the second mate wrote the coordinates of the amended waypoints next to them on the charts but he did not enter these coordinates in the GPS unit.

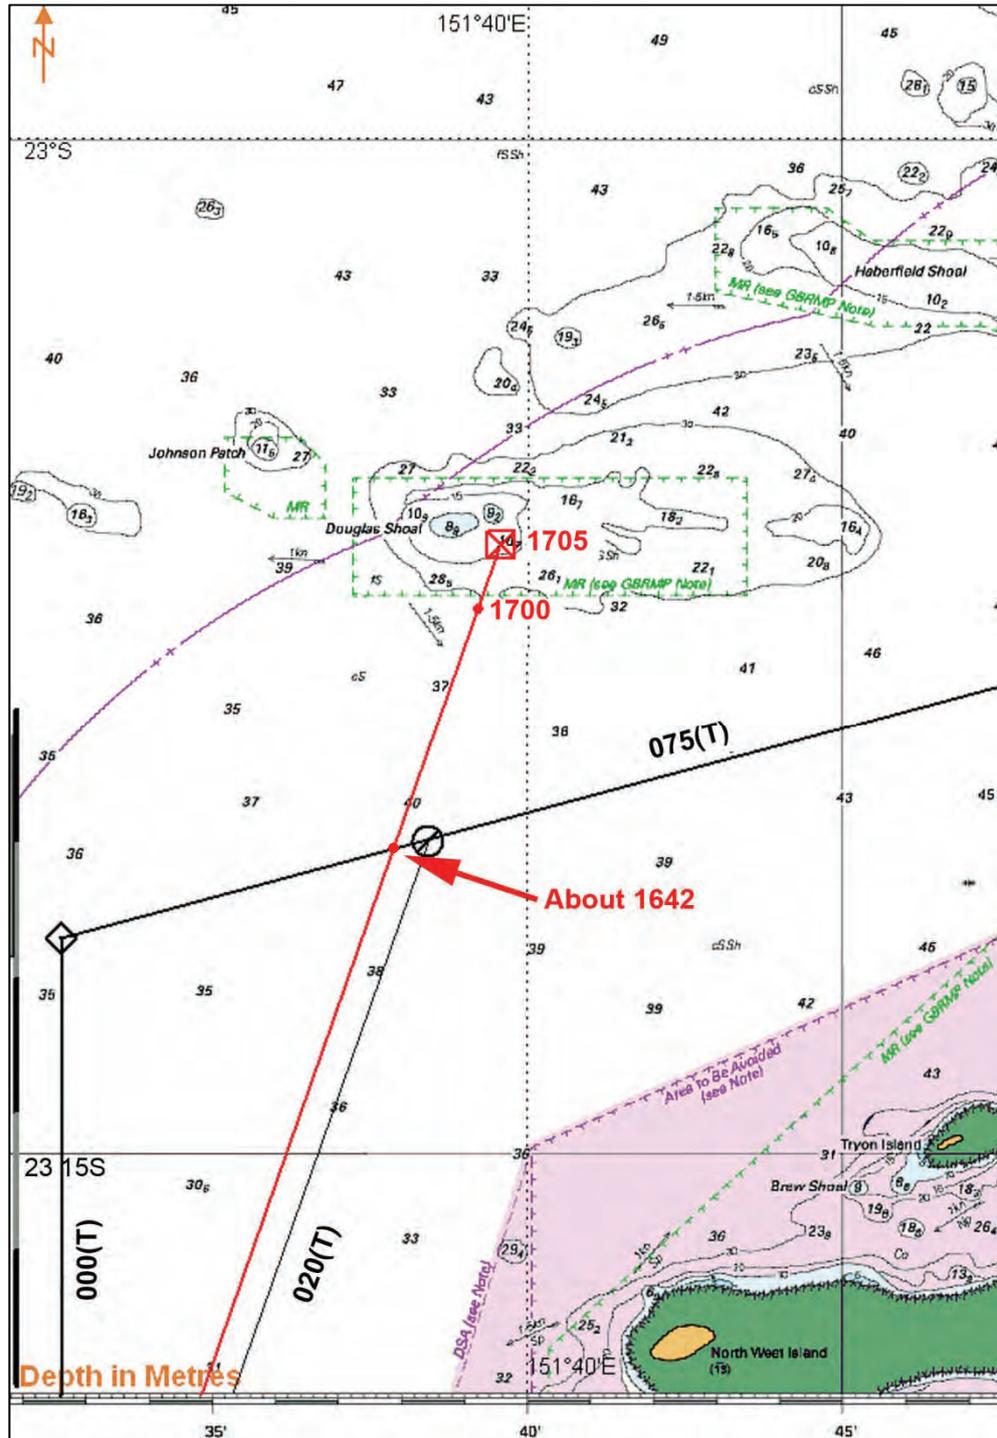
**Figure 6: Annotated section of navigational chart Aus 820 showing the original and amended route, and the ship's grounding position**

At about 1642, *Shen Neng 1* crossed the 075° (T) course line in the vicinity of the amended waypoint (Figure 6). On the ship's heading of 020° (T), Douglas Shoal was less than 5 miles ahead. The shoal, with a least depth of 8.9 m, gave no indication of its presence in the prevailing sea conditions.

By 1705, *Shen Neng 1* had come to a shuddering stop and grounded on a heading of 020° (T). The GPS unit indicated the position 23° 06.0'S 151° 39.6'E, close to a charted depth of 10.7 m on Douglas Shoal where the seabed is composed of coarse sand, shells and coral. It was almost low tide at Douglas Shoal.

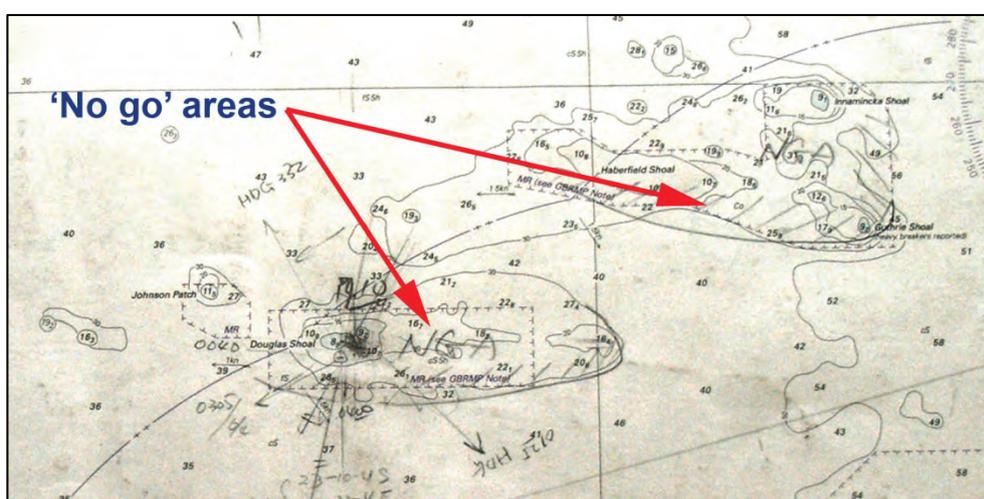
**Figure 7: *Shen Neng 1*'s navigational chart Aus 820 showing the 'no go areas' marked around Douglas and Guthrie/Haberfield Shoals**

At about 1700, the chief mate recorded the GPS coordinates 23°07.0'S 151°39.2'E in the GPS log book. This position was not on chart Aus 819 and he took out chart Aus 820 from the chart table drawer so that he could plot the position. As he placed the chart on the chart table, he noticed the ship's speed had decreased to about 8 knots. He then saw the 'no go area' marked on the chart near the Marine Park boundary around Douglas Shoal and realised the ship was entering the boundary area and closing on the shoal (Figure 7).

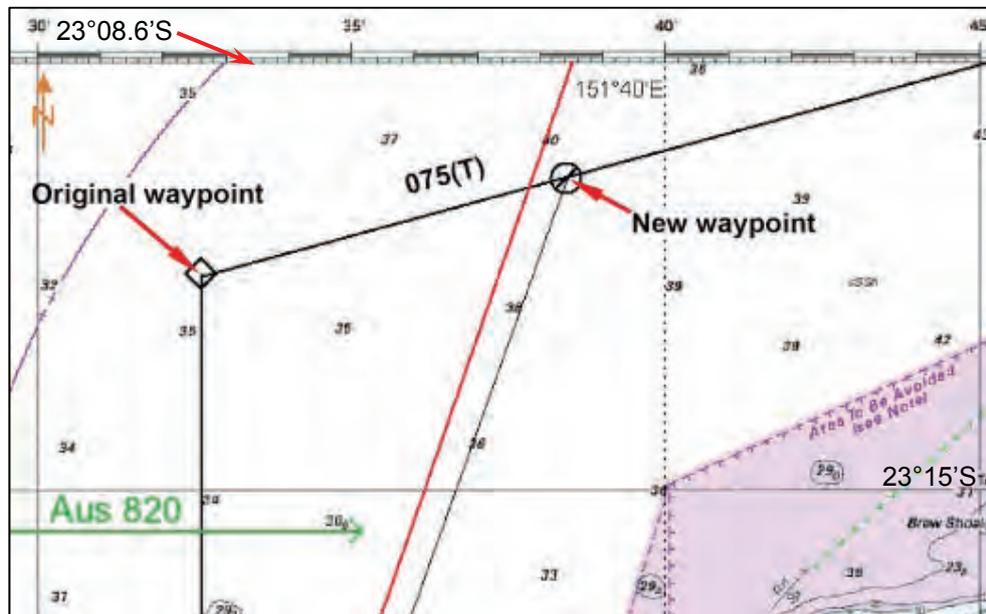
**Figure 11: Annotated section of navigational chart Aus 819 showing the northern limit of the chart**

The northern limit of Aus 819 was  $23^{\circ} 08.6'S$ , about 2 miles north of North Reef. This latitude runs through the middle of the passage and does not show the sea area to the north (Figure 11). It is in this sea area that unmarked underwater navigation hazards exist. Consequently, officers who are unfamiliar with transiting the passage may not be aware of the shallow water that exists to the north of the chart's northerly limit.

However, when *Shen Neng 1*'s chief mate took over the watch on 3 April, Aus 819 was on the chart table. While that chart was on the chart table, he could not identify the underwater dangers directly ahead of the ship as it followed the 020° (T) course.

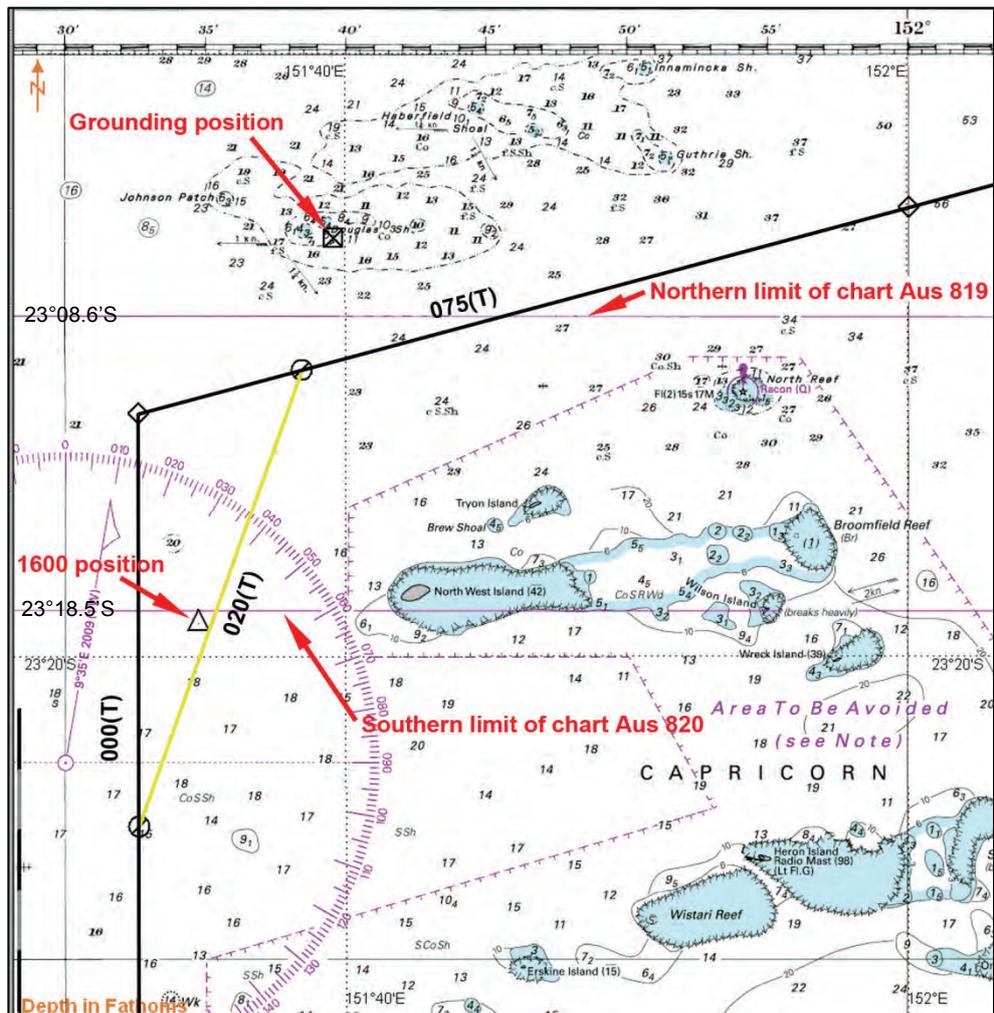
**Figure 12: Section of navigational chart Aus 366 showing the limit of charts Aus 819 and Aus 820**

By 1630, the ship would have travelled to a position where the most appropriate chart to use was Aus 820. However, no 1630 position was taken and so chart Aus 819 remained on the chart table until 1700. It was only then that the chief mate changed charts and saw the dangers ahead of the ship.

- The second mate did not plot the 1600 position fix on chart Aus 820. Consequently, chart Aus 819 remained on the chart table and this chart did not show the underwater navigation hazards that lay ahead of the ship as it followed the 020° (T) course.
