# Synopsis of Real ELT Incident in Alberta, Canada

Slide Presentation to Cospas-Sarsat  
Joint Committee 26<sup>th</sup> Meeting  
(of document JC-26/Inf.30)

# Real ELT Incident in Alberta, Canada

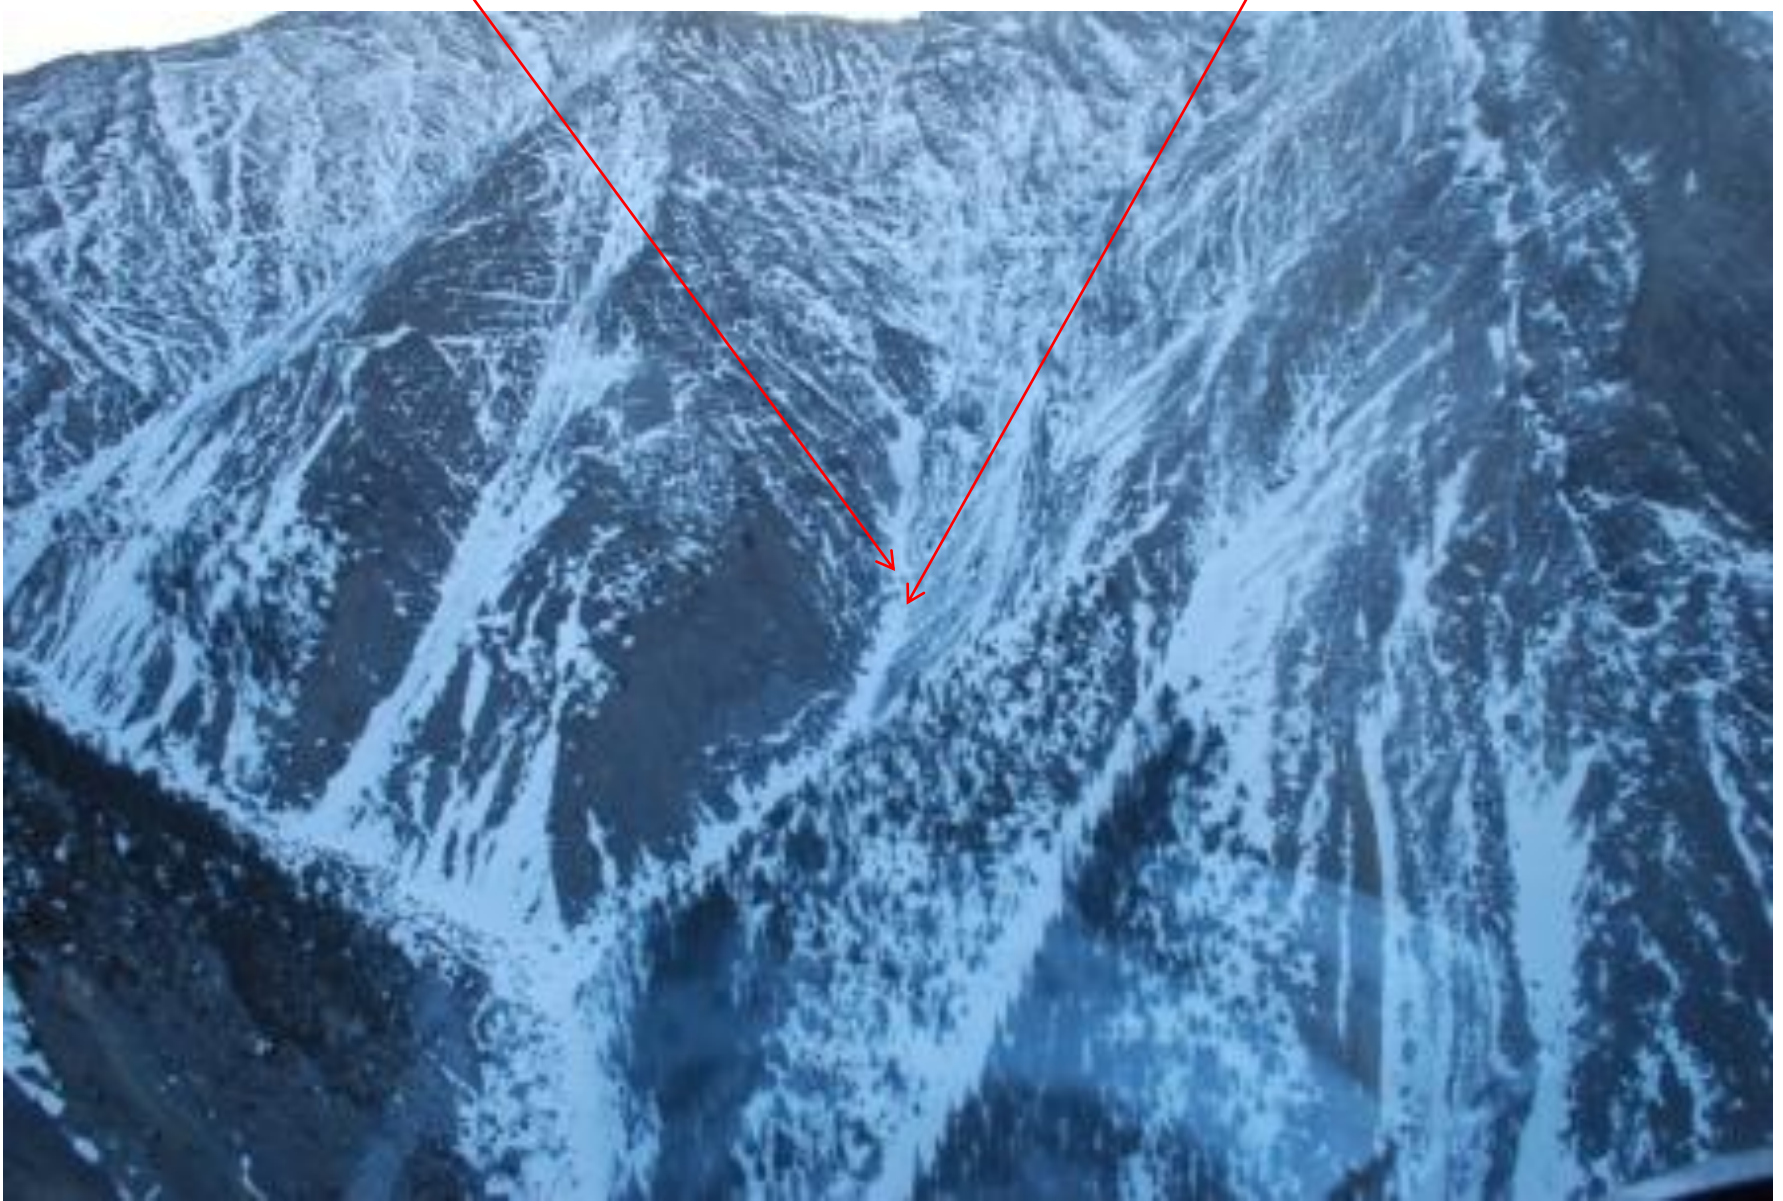
# Helicopter body and broken-off tail section / tail rotor

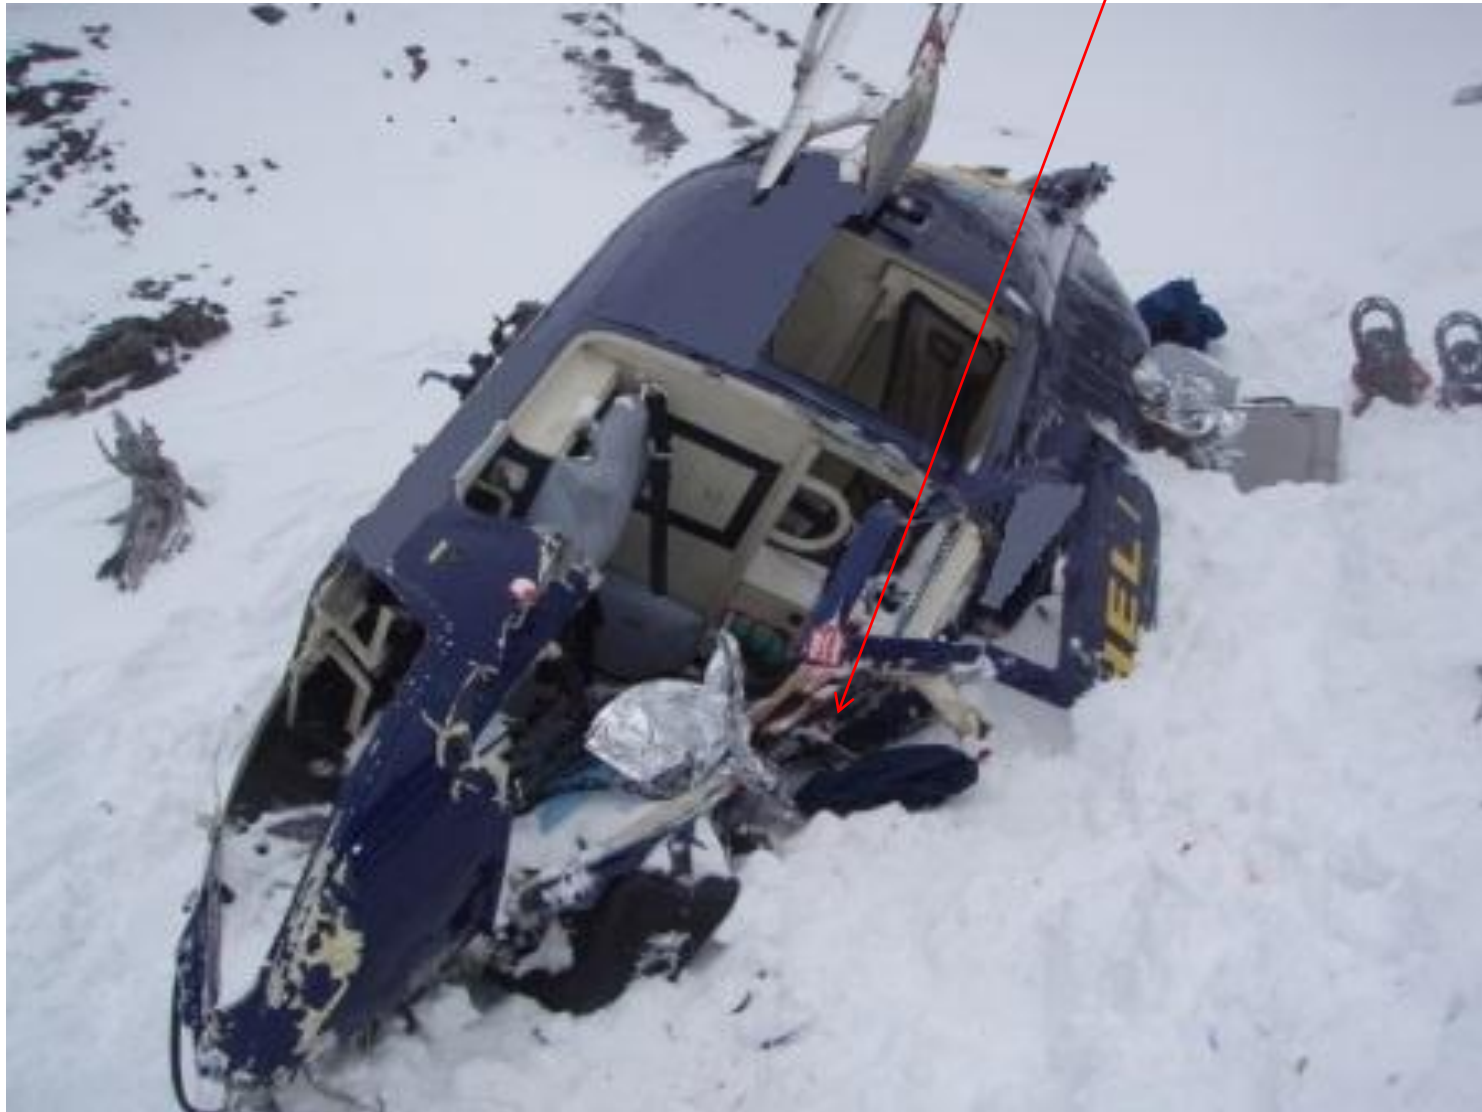
# Crashed Helicopter - and ELT still transmitted to C-S satellites for 24 hr (ELT rod antenna horizontal above snow)

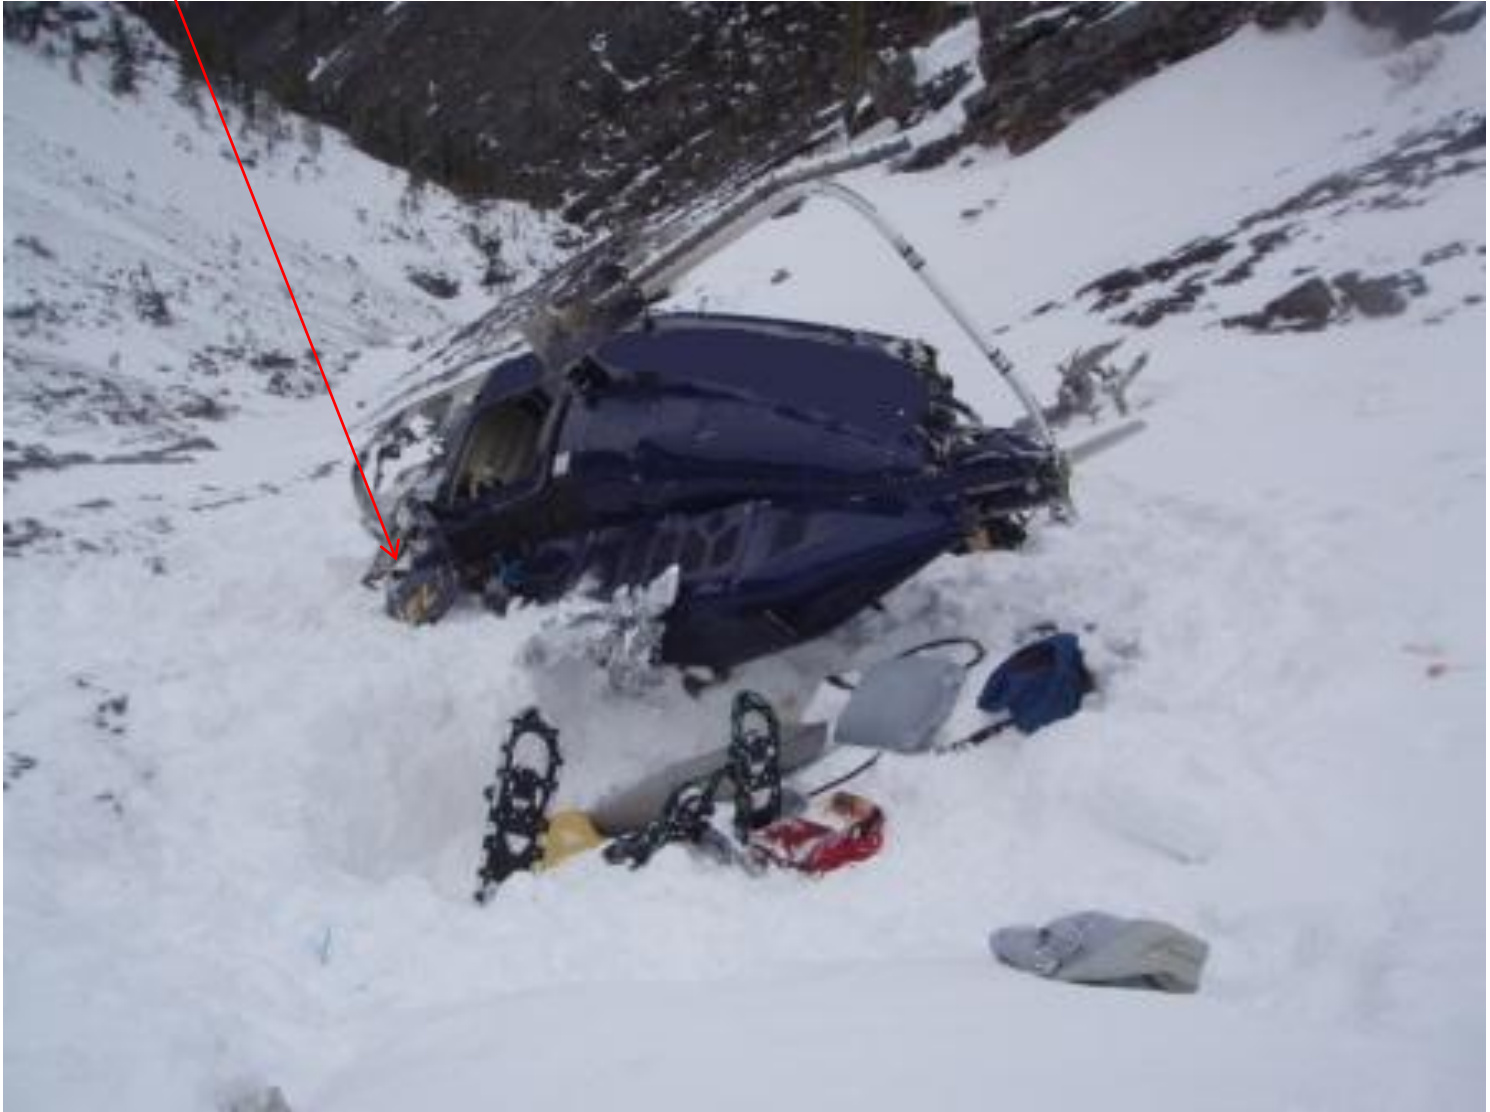
Crashed Helicopter on steep slope -  
ELT antenna laying horizontally just above snow

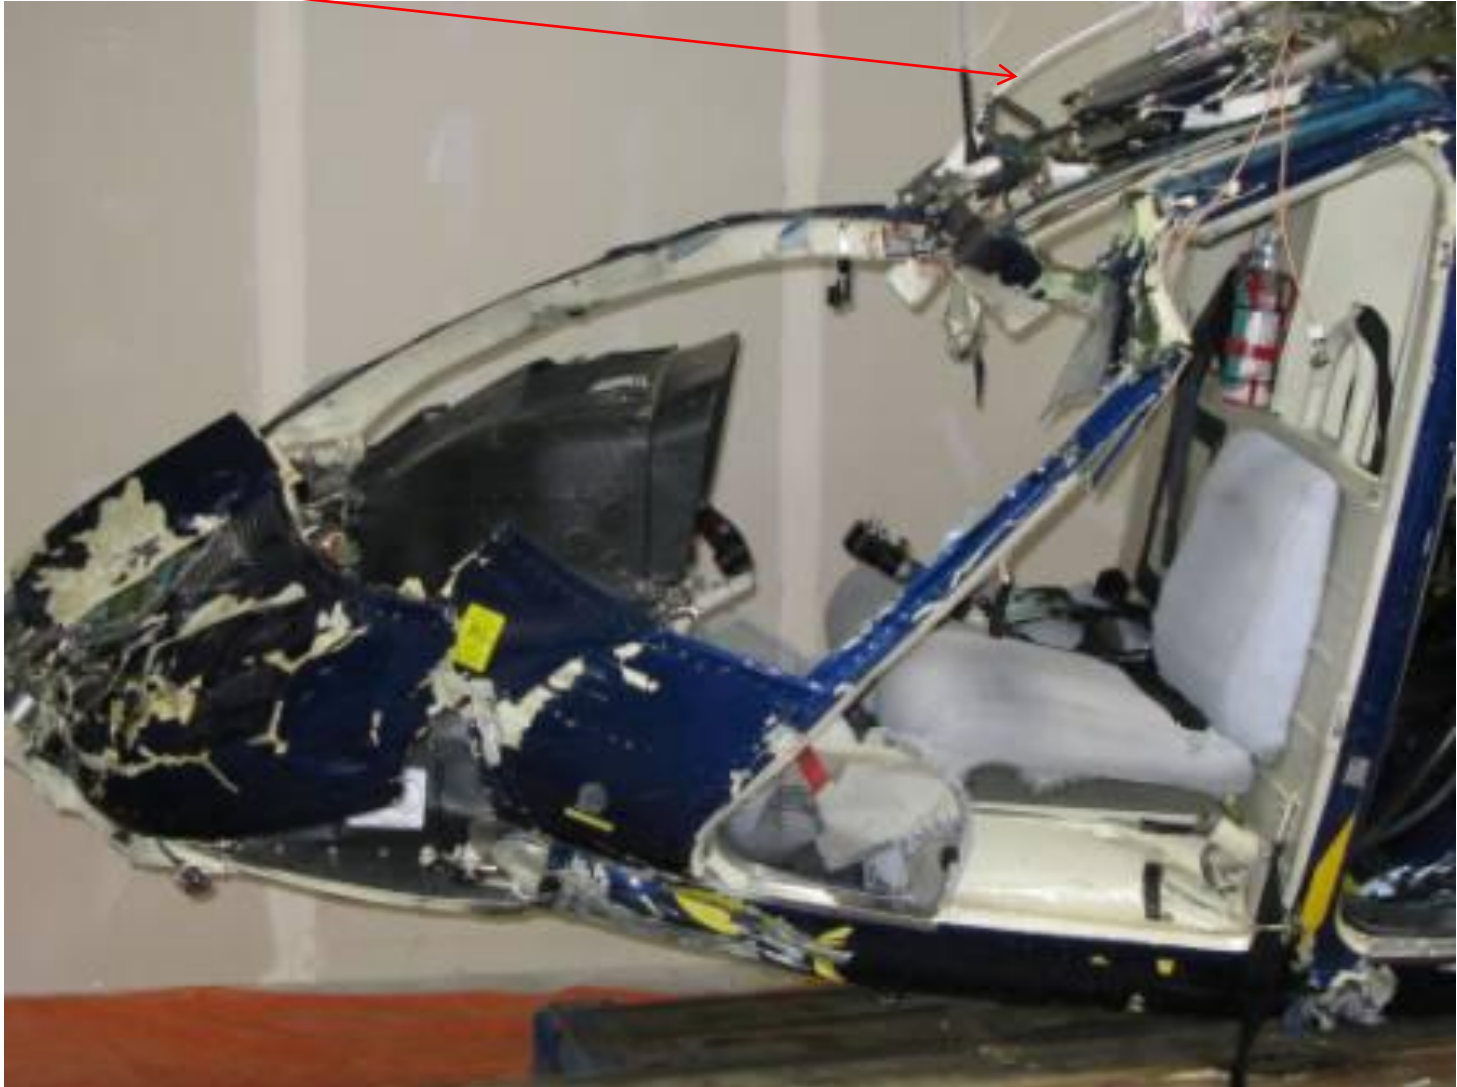
Wreckage in laboratory a week later -  
ELT rod antenna still intact and ELT removed for further investigation

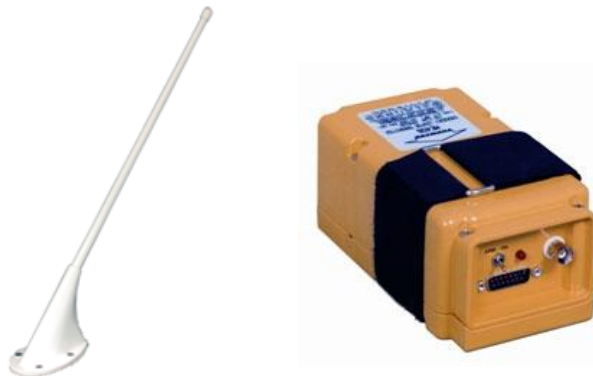
- Short Message (so no GNSS location encoded)
- Country Code 316=Canada
- ELT with 24-bit Aircraft Address (identifies specific aircraft # 12608349)
- C/S Type Approval Certificate No 188 (and from C/S data, this is Artex ELT model ME406 (probably HM version) and pictures from Artex website show:

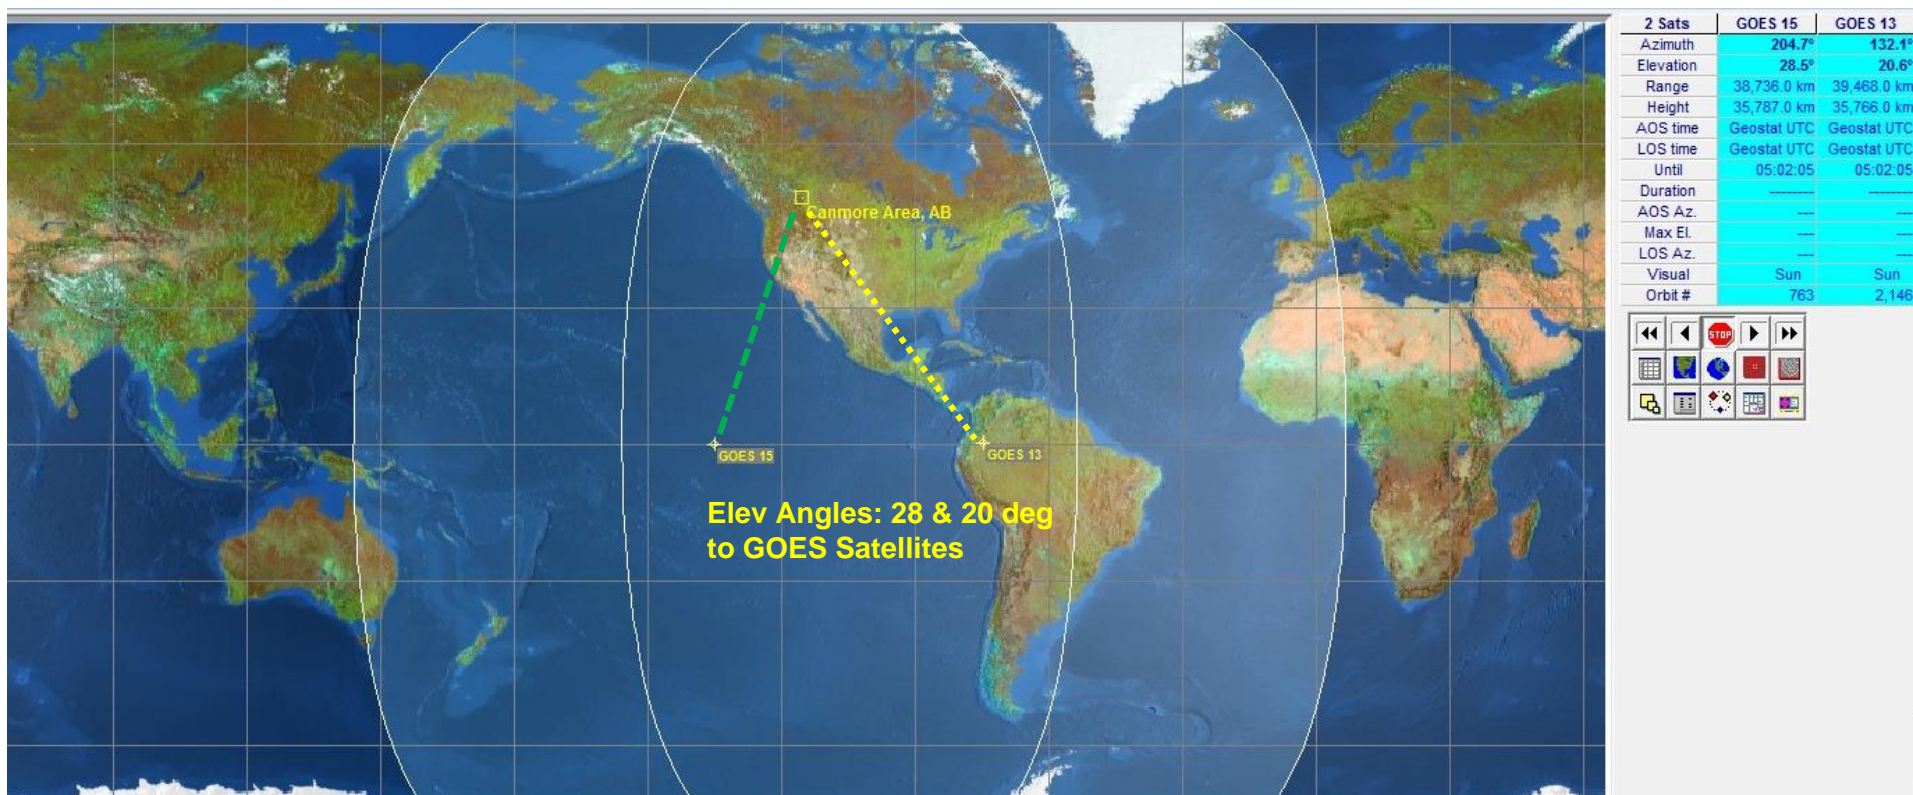
# GEOSAR Satellite Footprints

- NO Detections received from either GOES-East or -West satellites
- At 28 and 20 degree elevation angle at crash site
- Line-of-sight to GEOSAR satellites probably blocked by mountains

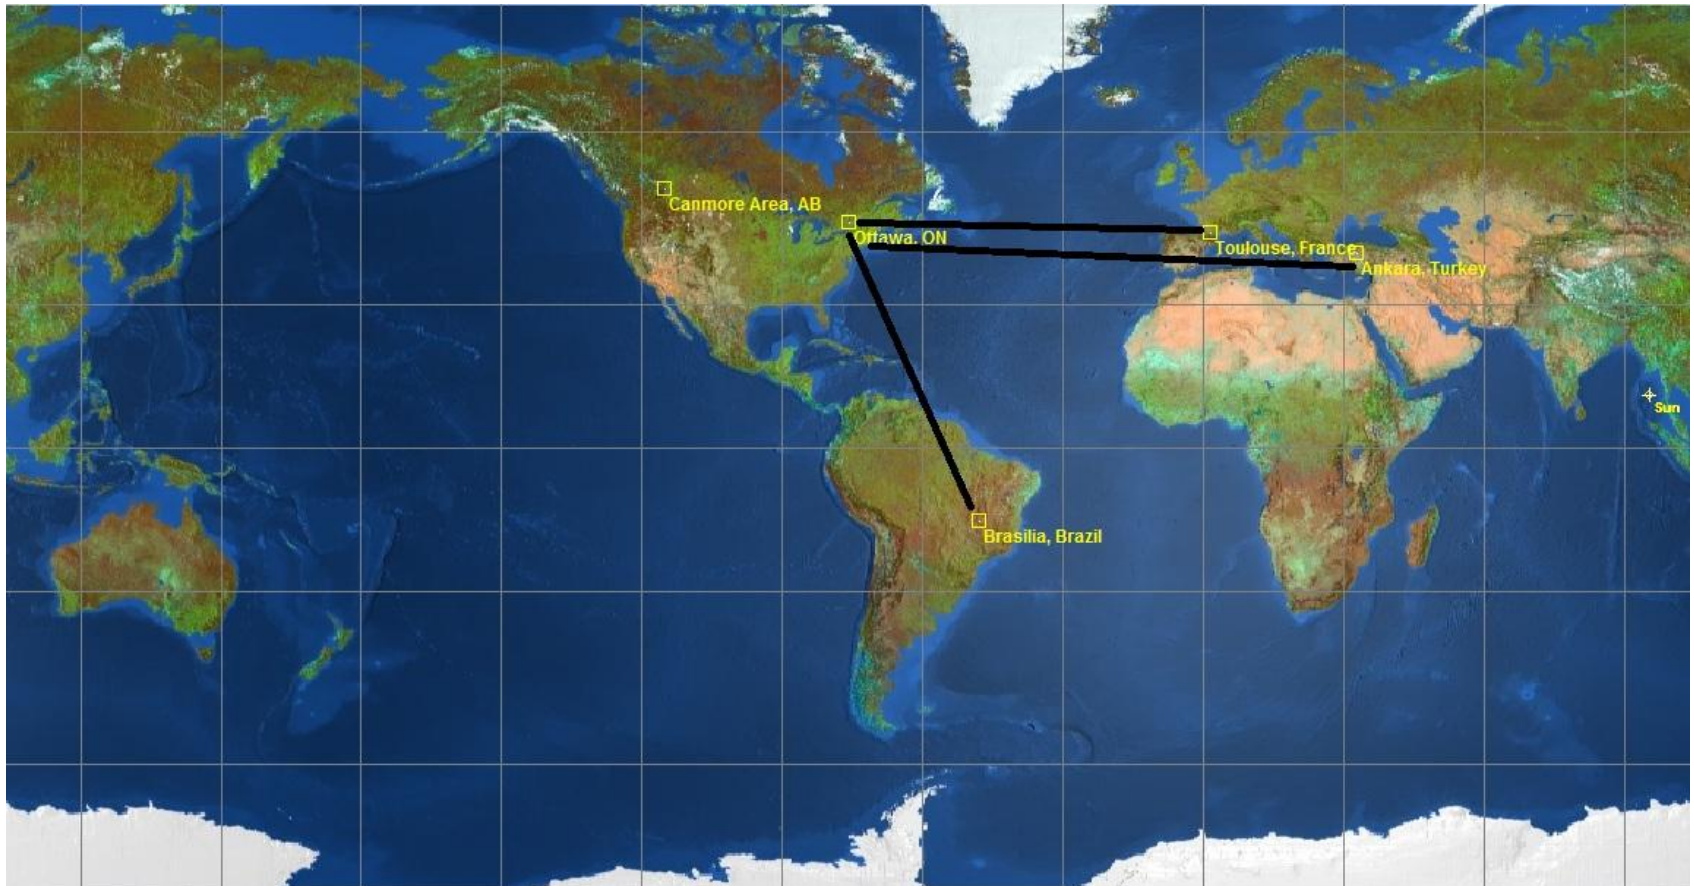
# TOA/FOA Data Received Automatically from MEOLUT Network between Canada, Brazil, Toulouse & Turkey

- Far away MEOLUTs provided data from crash site  
(Brazil 9800 km away, Toulouse 7800 km, and Turkey 9200 km)
