ANNUAL DIGEST

CHIRP

2023

Annual Digest of Reports and Insight Articles 2023-24

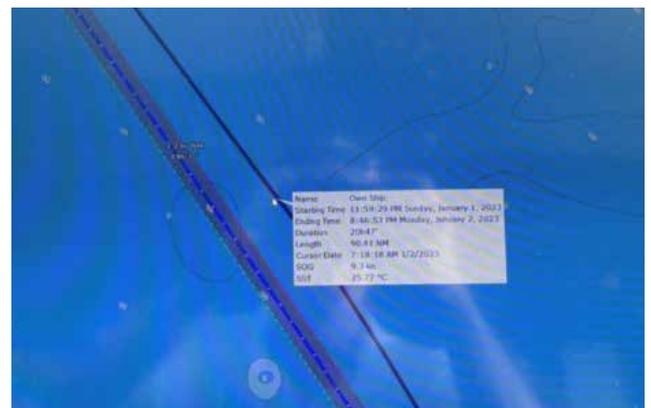
Screenshots of ECDIS (Electronic Chart Display and Information System) show that the planned track – shown as a dotted line – went over the top of a 1.9m shoal depth even though the vessel's draft was 2.3m. The vessel's course – shown as a solid line – was starboard of the planned track but still grounded because of a combination of shallow water, speed and squat. This resulted in the vessel dry-docking for several weeks for significant repairs.

The reporter explained that the master created all passage plans, but none were recorded in the vessel's navigation management system and that watchkeepers frequently had to deviate from the planned routes to avoid charted hazards. Our reporter was concerned that the master's proficiency in planning navigationally safe routes was lacking and that they sometimes struggled to interpret RADAR and ECDIS information. The reporter's employment was terminated when they raised these concerns through the company's safety reporting system.

Subsequent correspondence with the reporter revealed that to satisfy the owner or guests' requests to visit certain locations, the vessel often navigated to areas 'by eye,' i.e., visually detecting shallow areas because even large-scale charts lacked sufficient sounding data.

This report raises several issues. Firstly, although certificated, the master's navigational skills appear inadequate. It is vital that company managers validate the skill of masters and other senior officers and do not rely solely on the possession of a certificate as a measurement of competency. Secondly, route plans should always be cross-checked by another watchkeeper because even the best navigators can make mistakes.

CHIRP discussed with the relevant hydrographic office (HO) the issues experienced concerning navigating in the area related to the report. Crucially, a compliant ECDIS system must be used, and the charts must be updated to the latest edition and corrections. It was noted that an official ECDIS system with ENC was not used for the navigation of the vessel.

The HO placed great weight on using the sailing directions for the area as a pre-requisite before planning the passage. They contain valuable navigational information, including the nature of the seabed and the likelihood of shifting sandbanks, which in this case were prone to shifting. The vessel's speed must be set according to the under-keel clearance to avoid significant squat. Most fine-lined super yachts will trim by the stern when experiencing squat effect, and damage to the propellers and rudder can be expected if the vessel touches the seabed.

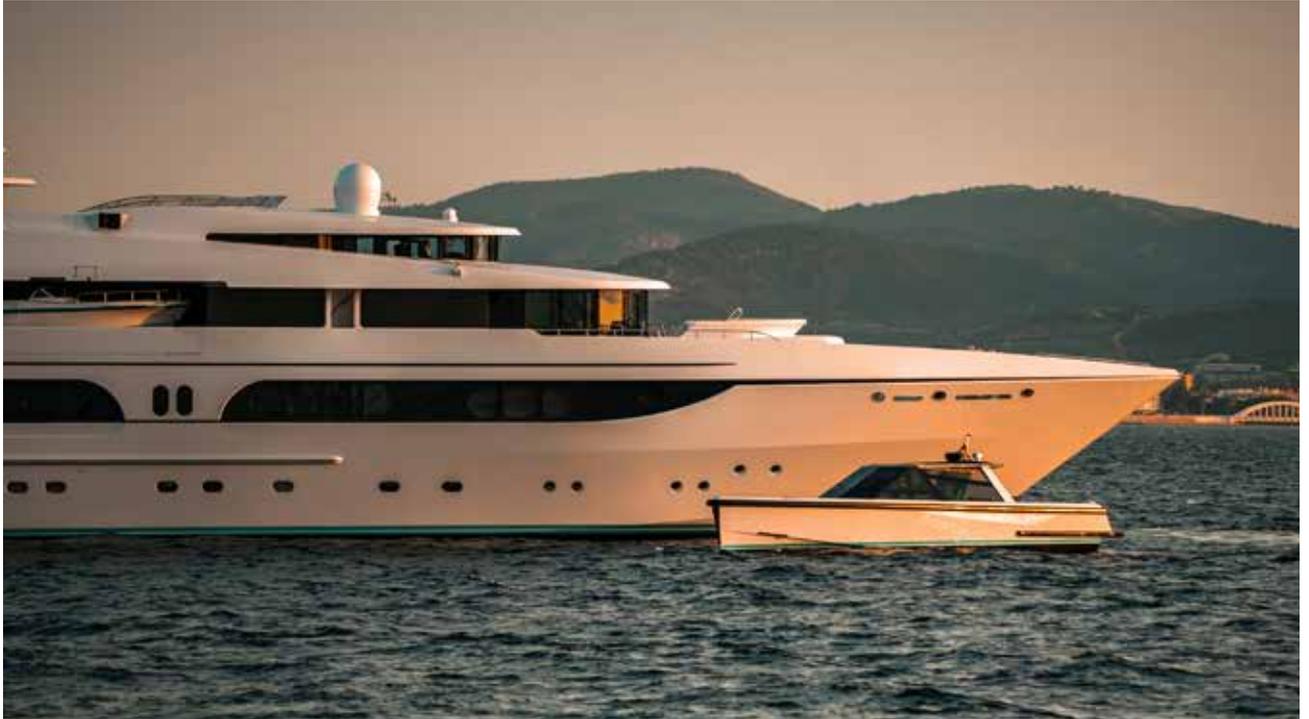
Our reporter was part of a team launching the tender from the shell door opening in calm weather conditions. After checking the hoist arrangement and securing the forward and aft lifting arms, the tender was lifted off the chocks. Another crew member went around to lower the outboard side of the tender chocks. Once they were back inboard, the crane arms were extended, but when the tender was halfway out, the bow suddenly dropped to the deck and slid into the water. Meanwhile, the aft end of the tender hit the deckhead, sending ceiling panels flying.

The cause was a sheared eye bolt thread. No additional loading was introduced while lifting the tender until the point of failure. The eyebolt conditions appeared to be in good condition, although there was some uncertainty about when they were replaced last.

Such incidents are not uncommon, and failure under load is often caused by inappropriate eyebolt design or weight-carrying capacity. When lifting, we naturally focus on the type and rating of the lifting strops used, but often the fixed lifting points are overlooked. Lifting eyebolts should have their capacity and test-date stamped on them or on a metal test certificate affixed immediately adjacent to them. Be sure to check your lifting arrangement for the tenders and work boats on your vessel!

When eyebolts are replaced, it is important to replace them with the same specification as the original, and properly fixed back in position. Another contributing factor can be the angle that the eyebolts make with the lifting shackles. If the lifting eyebolt and lifting strops are not in alignment, a shear force is produced which can cause failure of the eyebolt/s.

This cautionary report reminds us all never to stand or pass under any suspended load, as failure can occur unexpectedly either with inadequate or poorly maintained lifting equipment.

Overconfidence – Often there is an expectancy that the eyebolts will 'just work'. Be aware of such single points of failure in a lifting rig and pay particular attention to these areas, such as deformation, pitting or wear and tear.

Local Practices – As the eyebolts were replaced, it is essential that the original equipment parts were replaced with the same specification eyebolts. Thoroughness in the procurement process is critical to ensure that the tender can be lifted each time safely. How thoroughly do you procure original spare parts? Does your management have a procurement policy?

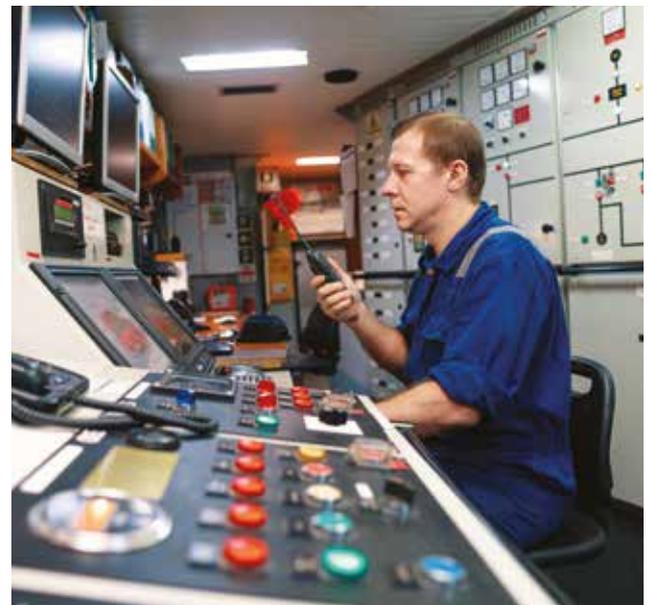
The 2nd engineer was in the engine room, next to the generators, helping the vibration specialist to gather readings from the gearbox. They noticed that a high-pressure fuel line to one of the generators had split and was spraying oil onto the hot exhaust manifold.

The 2nd engineer hit the generator’s emergency stop button, and the ship experienced a total electrical failure just as it was passing the breakwater. All navigational control was lost as a result, but luckily the emergency generator started, and power was quickly restored.

The chief engineer in the Engine Control Room should have requested permission from the bridge before changing the machinery state of the vessel so that the bridge team are always aware of the limitations of power and propulsion – especially when manoeuvring in or out of the harbour. Because the conversation would have also been broadcast over the loudspeakers in the engine room, those in the engine room would have been aware that only one generator was providing electrical power to the ship.

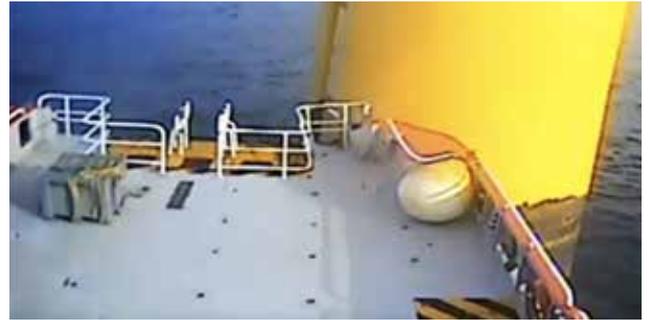
As a Crew Transfer Vessel (CTV) was returning to port at high speed, the master became distracted by a lengthy radio conversation and did not notice that the vessel had been pushed off course by the tide. It collided with a wind turbine tower at speed, causing significant damage to the vessel. The weather and visibility were good. As is common for vessels of this length, only the master was on the bridge; nobody else was keeping a lookout during the radio exchange.
