ATSB TRANSPORT SAFETY REPORT  
Marine Occurrence Investigation No. 274  
MO-2010-003  
Final

Independent investigation into the grounding of the  
Chinese registered bulk carrier

# Shen Neng 1

on Douglas Shoal, Queensland

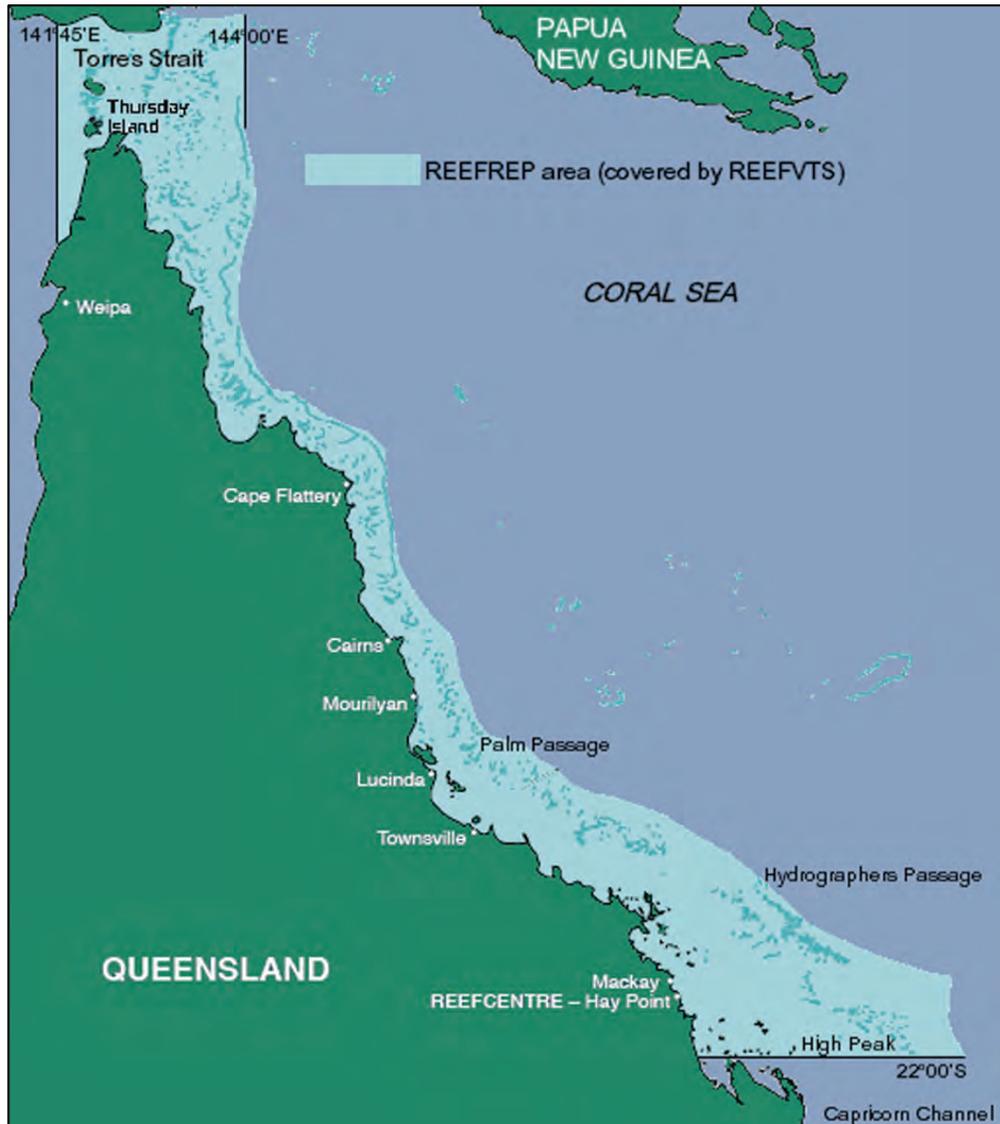
**Figure 2: Area covered by REEFVTS at the time of the incident**

At the time of the incident, REEFVTS provided VTS coverage of the Torres Strait and the northern part of the GBR. The southern limit of the REEFVTS area was at latitude 22°S, near High Peak Island, about 120 miles north of Gladstone (Figure 2).

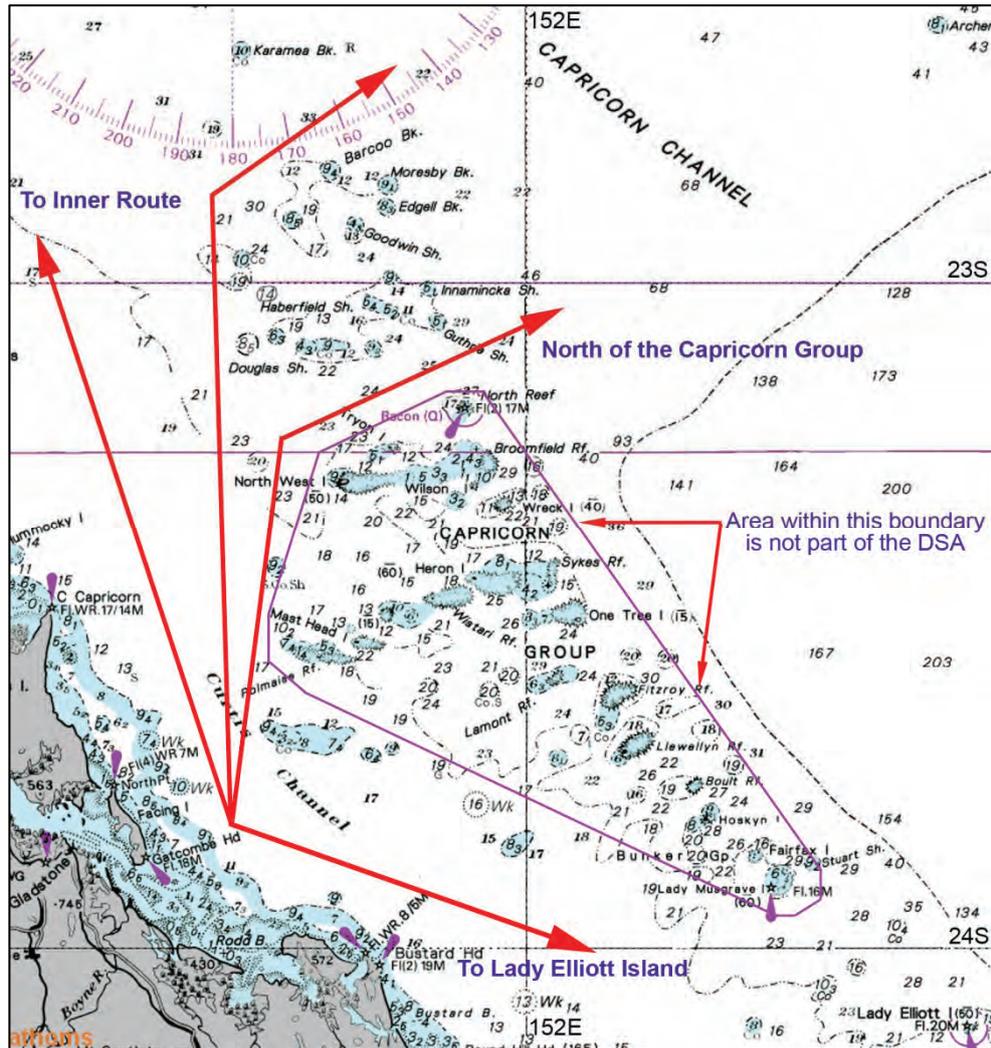
Figure 3: Route options for ships departing Gladstone

Another navigable passage to the north-northeast of Gladstone is between the Capricorn Group and Guthrie and Douglas Shoals (Figure 3). A powerful navigation light, with a racon<sup>14</sup>, is located on North Reef to assist in the safe navigation of ships through this passage. This passage is within the DSA and it is estimated that about half of the ships entering or exiting the GBR area off Gladstone use this passage, with the other half entering or exiting via Lady Elliott Island (Appendix A).

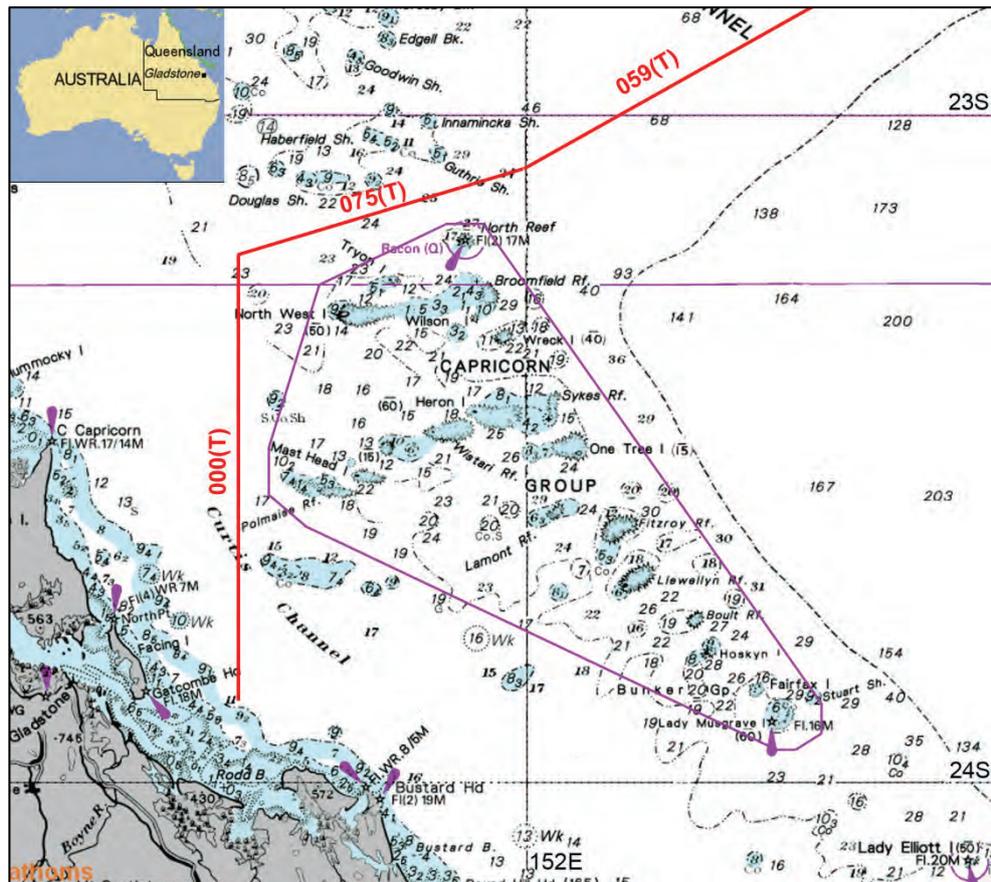
Figure 4: Shen Neng 1's intended passage from Gladstone

During the pilotage, the pilot noted from the chart that the master intended to steam north from the pilot boarding ground and exit the GBR area via the passage to the north of North West Island and North Reef (Figure 4).

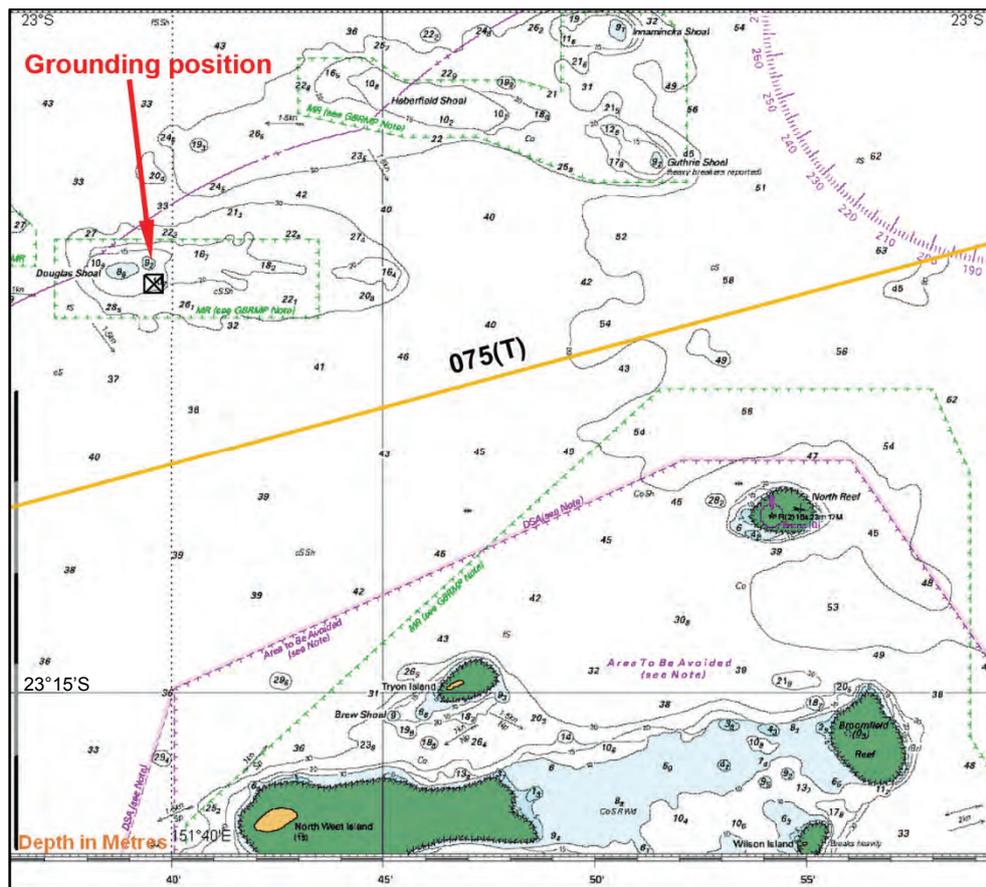
**Figure 10: Section of navigational chart Aus 820 showing *Shen Neng 1's* planned course through the passage**

reciprocal courses of those used on the inbound passage. The 075° (T) course would take the ship along the centre of the passage, well clear of any navigational dangers and the DSA and 'area to be avoided' limits (Figure 10). The ship would then exit the GBR Marine Park through the Capricorn Channel and into the Coral Sea.
